## Accessibility Audit

Church Hill Nursery School & Children's  
Centre  
47 Woodbury Road  
London  
E17 9SB

Date 10/12/2013

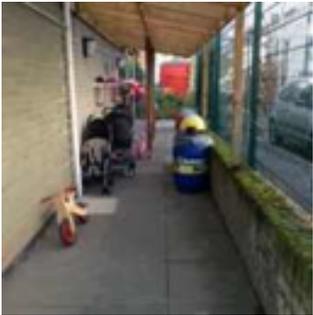
<p>Appendix 1</p>

1.3 - Wide enough? If a route or pathway is narrow, is there a suitable passing place for wheelchair users? Is plantation trimmed back and are low branches avoided?	No	There are some items positioned in the route between Kitchen and Main Entrance restricting clear width causing potential difficulties accessing for wheelchair users.

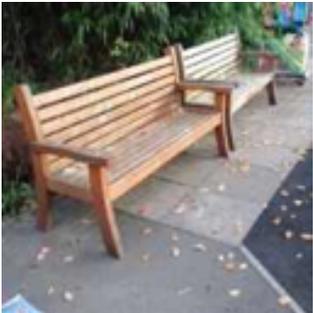
<p>Appendix 10</p> </div>

<p>Appendix 9</p> </div> </div>		
<p>1.10 - Is there appropriate seating within the playing areas? Is there space to the side of seating to allow a wheelchair user to park alongside a seated companion?</p>	<p>Yes</p>	<p>The seating has colour contrast against the surroundings and there are armrests to aid people with ambulant disabilities.</p> <p>Additionally the seats have a space either side to allow a wheelchair user to park alongside a seated companion.</p>

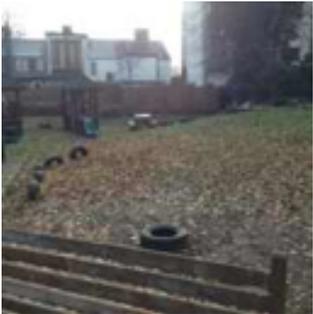
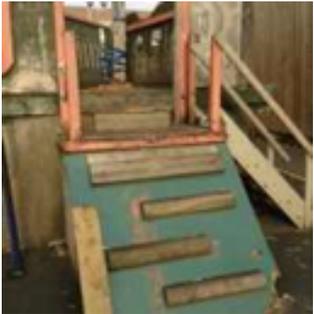
Question	Response	Details
1.11 - Where there is playing equipment, is there a section which is accessible for people with mobility disabilities?	No	<p>The play equipment should not be positioned on the grass. If there are a lot of disabled people at the school then there should be wheelchair friendly equipment.</p> <p>Play equipment appears to have no climbing ramps easy to use for those with ambulant/mobility disabilities.</p> <p>The play equipment is not brightly painted to contrast with the background upon which it is seen so that the lower pieces could cause a trip hazard for those with impaired vision.</p>

<p data-bbox="571 922 687 943">Appendix 12</p>	
BS8300 - Uneven surfaces, surfaces of loose materials (e.g. gravel) and large gaps between paving materials cause problems for wheelchair users, people with impaired vision and people who are, generally, unsteady on their feet.

1.11	The play equipment should not be positioned on the grass. If there are a lot of disabled people at the school then there should be wheelchair friendly equipment.  Play equipment appears to have no climbing ramps easy to use for those with ambulant/mobility disabilities.  The play equipment is not brightly painted to contrast with the background upon which it is seen so that the lower pieces could cause a trip hazard for those with impaired vision.	Site management should undertake a review.	<b>M</b>

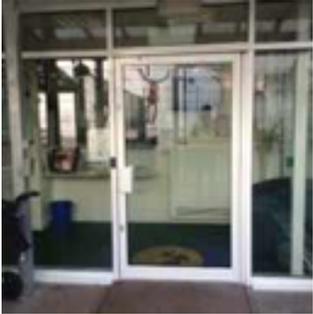
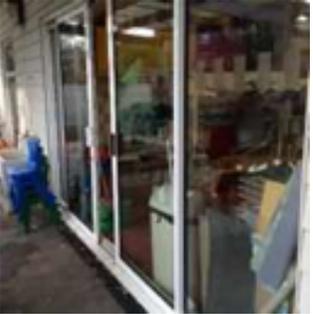
Appendix 13	Appendix 14

5.1 - Main school entrances easy to find? Is the entrance clearly distinguishable from facade?	No	Most entrances - The white doors are not clearly seen on approach owing to a lack of colour contrast against the white facade.

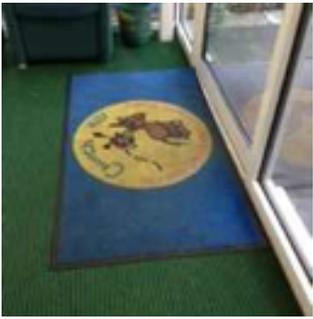
<p>Appendix 25</p> </div>

5.10 - Weather mat of firm texture and flush with floor?	No	There is a weather mat at the main reception which is a potential trip hazard.
<div style="text-align: center;">

5.10	There is a weather mat at the main reception which is a potential trip hazard.	Remove the door mat.	<b>N</b>	
7.2	The structural column has no colour contrast or markings at two heights in accordance with BS8300.	Well contrasted markings should be provided at two heights to the column. Refer to BS8300 for guidance.	<b>N</b>

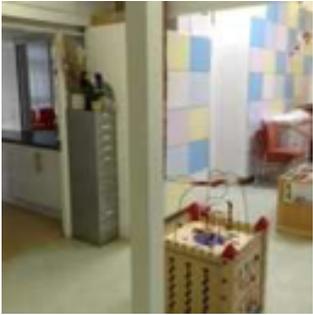
<p data-bbox="248 675 367 699">Appendix 29</p>

Question	Response	Details
7.2 - Free from obstruction to wheel chair users and from hazards to people with impaired sight? Are there any internal columns that have a lack of colour contrast?	No	The structural column has no colour contrast or markings at two heights in accordance with BS8300.

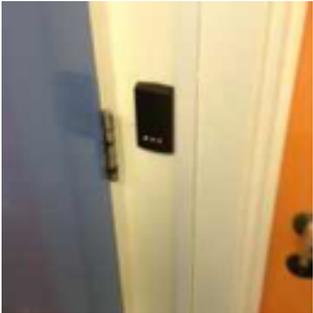
<p>Appendix 34</p> </div> <div style="text-align: center;">

8.7 - Where there are security keypads or readers, are these suitably positioned for potential staff members with disabilities?	No	<p>Nursery School and to the Waiting Area - The press to open buttons are positioned too high off the floor level causing difficulties reaching for wheelchair users and people of small stature and the controls are not easy to use for people with dexterity impairment and impaired vision.</p> <p>All security key passes are positioned not too high off the floor level making it easy to reach for wheelchair users and people of small stature and controls are easy to use for people with dexterity impairments.</p>
<div style="display: flex; justify-content: space-around; align-items: center;"> <div style="text-align: center;">

8.7	Nursery School and to the Waiting Area - The press to open buttons are positioned too high off the floor level causing difficulties reaching for wheelchair users and people of small stature and the controls are not easy to use for people with dexterity impairment and impaired vision.	Lower the press to open buttons to 1100mm off the finished floor level.  Replace key pads with swipe card system.  According to BS8300 - Disabled people with a weak hand grip or poor co-ordination, find that using a card to open a door lock is easier.	<b>OG</b>

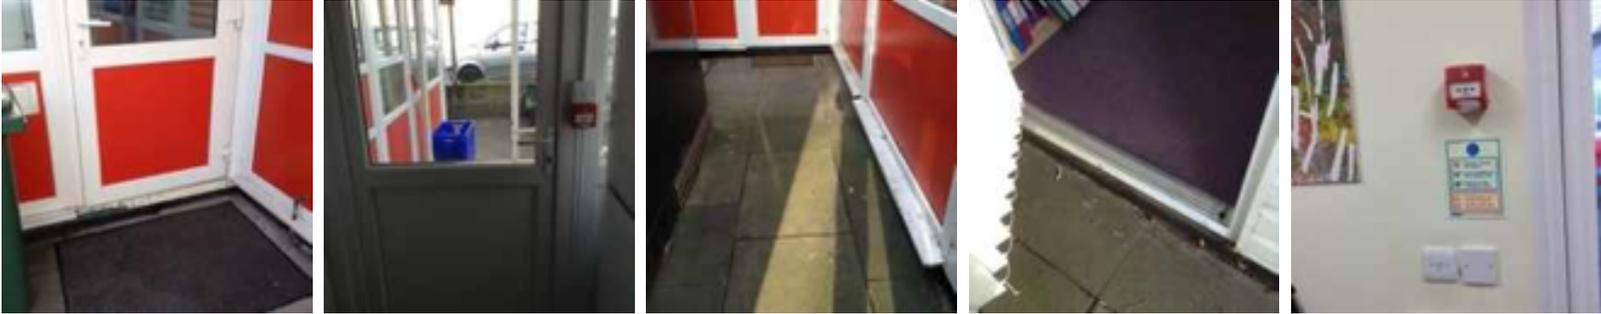
Question	Response	Details
17.2 - Ground floor exit routes accessible to all, including wheel chair users, as entrance routes?	No	<p>Numerous fire exits - The thresholds are not level with the floor and do not have ramps making egress potentially difficult for wheelchair users.</p> <p>Apart from kitchen door, most fire exit doors have push to open bars for those with dexterity impairments.</p> <p>One of the break glass buttons is positioned too high off the floor level causing difficulties reaching for wheelchair users or people of small stature.</p>
