Accessibility Audit

Low Hall Nursery School

Low Hall Lane

Date 07/03/2017

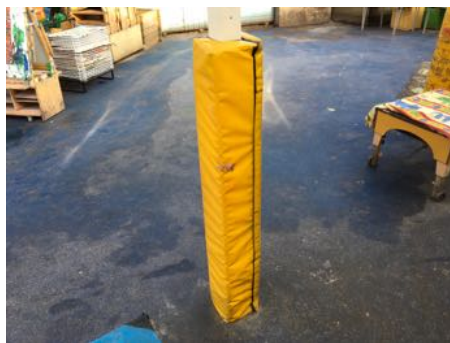
Photo 2

Question	Response	Details
1.6 - Free from hazards such as bollards, litter bins? Are planting features kept to a minimum and are they colour contrasted?	D	On approach to the nursery, the light posts and traffic posts do not feature contrast markings at two heights in accordance to BS8300.
<div data-bbox="120 363 443 608" data-label="Image"> </div> <div data-bbox="232 652 320 679" data-label="Caption"> <p>Photo 1</p> </div>		
1.7 - Free from hazardous building features such as outward-opening doors, windows or overhangs? Do columns or structural posts have markings at two heights?	Yes / N/A	No issues to report. The external posts within the children's playing areas have been padded.
<div data-bbox="120 888 443 1133" data-label="Image"> </div> <div data-bbox="232 1177 320 1204" data-label="Caption"> <p>Photo 2</p> </div>

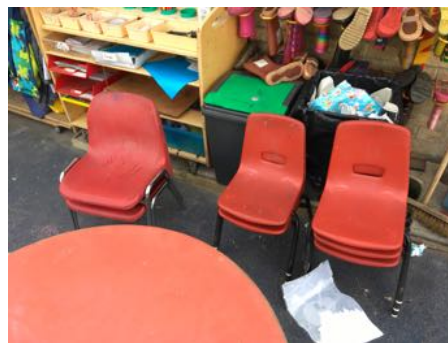
Photo 3

Question	Response	Details
1.8 - Adequate seating provided along routes? Is there suitable seating within the play areas?	D	<p>There is a lack of seating with armrests within areas that parents pick up and drop off their children.</p> <p>There is a lack of suitable seating with armrests within the rear playground area.</p>
<div>

1.8	<p>There is a lack of seating with armrests within areas that parents pick up and drop off their children.</p> <p>There is a lack of suitable seating with armrests within the rear playground area.</p>	<p>Provide benches with armrests. Ensure that the armrests are well contrasted and that there is a space either side of the seat so that a wheelchair user can park alongside a seated companion</p> <p>Seating in resting places should meet the following recommendations.</p> <p>1) There should be a variety of seat heights, ranging from 380 mm to 580 mm, within which a height of 480 mm is suitable for wheelchair users.</p> <p>2) Armrests should be provided to help people lower themselves onto the seat and stand up.</p> <p>3) Where the seat is set at a height suitable for wheelchair users, armrests should not be at the extreme end of the seat but set in so as not to restrict the lateral transfer from a wheelchair to the seating. they should also not restrict front or oblique transfer.</p> <p>4) A supportive back-rest should be incorporated for at least 50% of the length of the seat.</p>	M

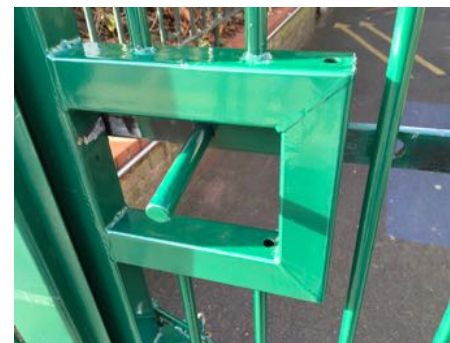
Photo 4

Question	Response	Details
1.9 - Are entrance gates appropriately colour contrasted and do intercoms have accessible features?	A	<p>There are three entrance gates. The first gate off the street, a second gate near the main entrance and a third gate off the car park area (owned by the adjacent medical centre)</p> <p>The first entrance gate has a high latch which is out of reach for wheelchair users and for persons of short stature. This has been installed not for security but to ensure that children do not open the gate. It is recommended that an assistance bell along with signage be installed, the existing latch should remain.</p> <p>The second gate has an intercom which is positioned too high off the ground floor level for wheelchair users and for persons of short stature. The release on the inside is also too high.</p> <p>All of the entrance gates including off the car park do not suitably colour contrast and there is no contrast to the controls to aid people with impaired vision.</p>

Item Ref.	Details / Issue	Recommendation	Est Cost	Action Taken
PRIORITY A				
1.9	<p>There are three entrance gates. The first gate off the street, a second gate near the main entrance and a third gate off the car park area (owned by the adjacent medical centre)</p> <p>The first entrance gate has a high latch which is out of reach for wheelchair users and for persons of short stature. This has been installed not for security but to ensure that children do not open the gate.</p> <p>The second gate has an intercom which is positioned too high off the ground floor level for wheelchair users and for persons of short stature. The release on the inside is also too high.</p> <p>All of the entrance gates including off the car park do not suitably colour contrast and there is no contrast to the controls to aid people with impaired vision.</p>	<p>It is recommended that an assistance bell along with signage be installed, the existing latch should remain. Safety of children takes precedence over accessibility.</p> <p>The intercom should be repositioned. Ensure all operating parts are within 1050mm off the landing level and ensure no obstruction below. Ensure that it is well contrasted against the background upon which it is seen. It is recommended that the release button on the inside be lowered to 1200mm off the ground floor level.</p> <p>Add colour contrast to the gates and their controls to aid people with impaired vision. Low priority.</p>	M / OG

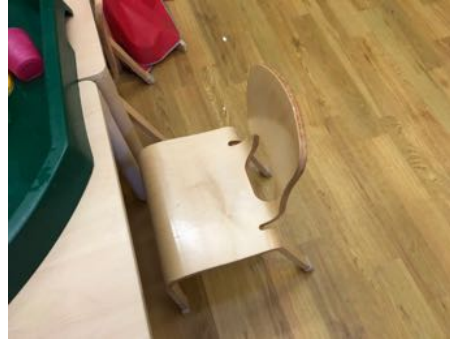
Photo 51

14.3 - Are a number of chairs with armrests available within each of the key areas?	D	There is a chair with armrests provided for children. However many of the seats (along with the tables) are the same colour as the surrounding floor. This could cause a potential collision hazard.
<div data-bbox="120 1024 441 1268" data-label="Image"> </div> <div data-bbox="230 1313 327 1337" data-label="Caption"> <p>Photo 50</p> </div> <div data-bbox="452 1024 775 1268" data-label="Image"> </div> <div data-bbox="564 1313 658 1337" data-label="Caption"> <p>Photo 51</p> </div>

14.3	There is a chair with armrests provided for children. However many of the seats (along with the tables) are the same colour as the surrounding floor. This could cause a potential collision hazard.	Site management should review and take the appropriate action. Ideally the seats and tables should be colour contrasted against the flooring, especially since they are all sporadically positioned. This can be achieved at the next refurbishment by changing the furniture or by changing the colour of the flooring.	M
