## Accessibility Audit

Church Hill Nursery School & Children's  
Centre  
47 Woodbury Road  
London  
E17 9SB

Date 10/12/2013

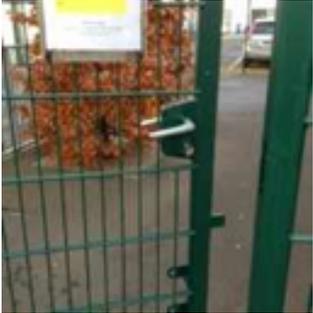
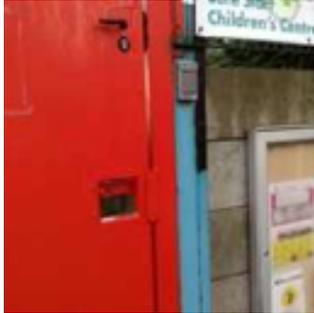
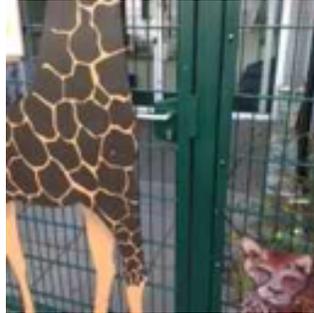
Question	Response	Details
<p>1.9 - Are entrance gates appropriately colour contrasted and do intercoms have accessible features?</p>	<p>No</p>	<p>Entrance gates do not have suitably colour contrasted features to the controls and surround to aid people with impaired vision.</p> <p>Red gate - The control is positioned too high off the ground level causing difficulties reaching for wheelchair users and people of small stature.</p>
<div style="display: flex; justify-content: space-around; align-items: center;"> <div style="text-align: center;">

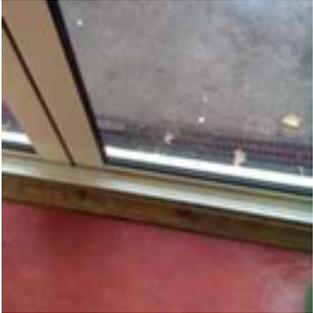
Question	Response	Details
5.2 - Door opening wide enough for all users? Enough space alongside leading edge for a wheel chair user to open the door while clear of the door swing?	Yes	
5.3 - Level or flush threshold?	No	Nursery School entrance - The two doors have an upstand of approx. 40mm denying access for wheelchair users.

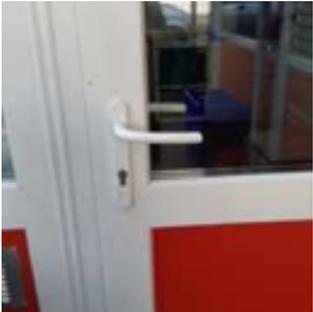
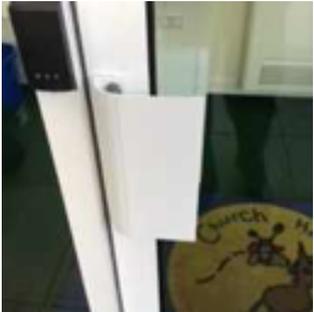
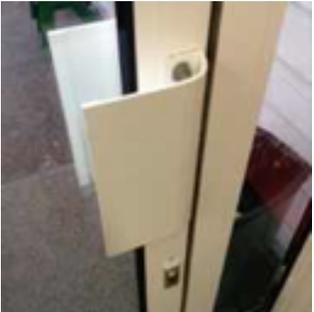
Question	Response	Details
5.6 - Door control at a suitable height for both standing and seated users? Are door handles clearly located, easy to use and grip?	No	<p>Most entrances have white door handles against a white background which are not suitably contrasted.</p> <p>Most door handles are not of the preferred profile.</p>
<div style="display: flex; justify-content: space-around; align-items: center;"> <div style="text-align: center;">

5.6	Most entrances have white door handles against a white background which are not suitably contrasted.  Most door handles are not of the preferred profile.	Add colour contrast to the door handles and surround.  Replace with well contrasted BS8300 compliant furniture to the entrance doors.	<b>OG</b>

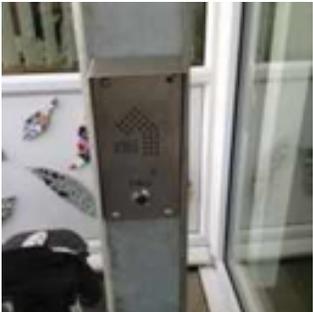
<p>Appendix 19</p> </div>

5.8 - Entry phones and intercoms detailed to allow use by people with sensory or mobility impairments? Is there an LED display to accommodate people with hearing impairments?	No	Main Entrance - There is no LED display provided to aid people with impaired hearing. The buttons lack colour contrast against the background to aid people with impaired vision.
<div style="text-align: center;">

5.8	Main Entrance - There is no LED display provided to aid people with impaired hearing. The buttons lack colour contrast against the background to aid people with impaired vision.	<p>Replace with intercom which has tactile definition to the buttons and an LED display.</p> <p>Ensure all operating parts are within 1050mm off the landing level and ensure no obstruction below.</p> <p>Ensure that it is well contrasted against the background upon which it is seen.</p> <p>Note AD M is not descriptive on intercoms and BS8300, best practice should be referred to. In all cases when installing intercoms specialist advice should be sought.</p>	<b>OG</b>

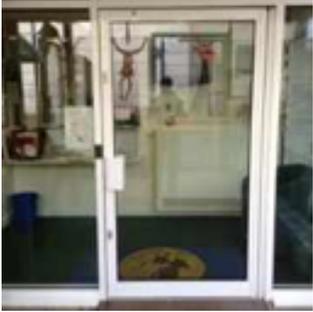
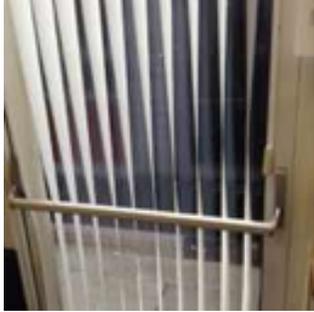
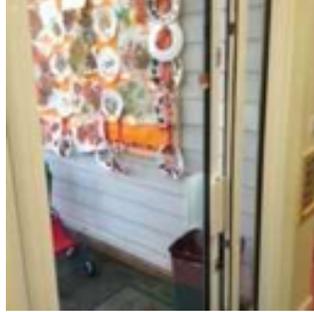
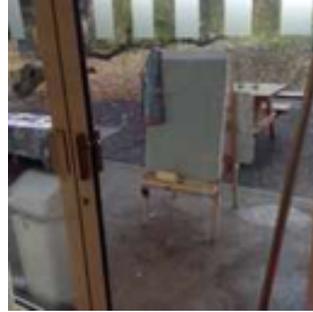
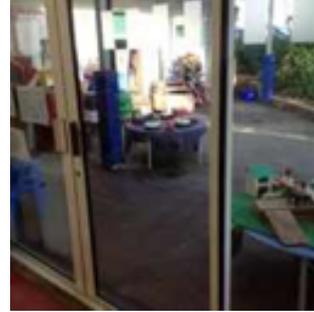
Question	Response	Details
5.9 - Glazed entrance door: markings for safety and visibility? If manifestations are provided, are these suitably colour contrasted against their background?	No	Numerous glazed doors and full height glazed windows - There are no manifestations at two levels.
<div style="display: flex; justify-content: space-around; align-items: flex-end;"> <div style="text-align: center;">

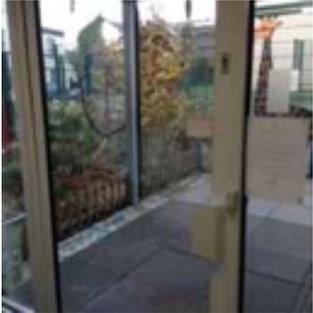
<p data-bbox="248 1066 367 1090">Appendix 26</p>		
6.2 - Transitional lighting? Is the entrance lobby and reception area well illuminated?	Yes

Question	Response	Details
5.12 - If automatic doors are operated via a push pad rather than a sensor, are these clearly seen on approach? (internally and externally)	N/A	
5.13 - Is there a second set of doors / lobby doors and are these accessible?	N/A	
AD M - The presence of the door should be apparent not only when it is shut but also when it is open. Where it can be held open, steps should be taken to avoid people being harmed by walking into the door		
<b>Checklist 6 - Reception Areas and Lobbies</b>		
6.1 - Clear view in from outside? Can receptionists see visitors and provide assistance if necessary?	Yes	The main entrance is glazed allowing a clear view into the reception area.

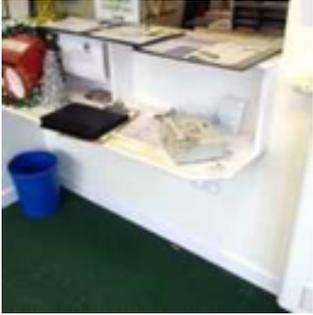
<p data-bbox="248 778 365 802">Appendix 27</p>

Question	Response	Details
6.3 - Reception/desk/counter/ checkout suitable for approach and use from both sides by people either standing or seated?	No	Main Reception - The desk is at approx 1100mm high, this should have a lower section plus sufficient knee space both sides for people sitting or wheelchair users. Ideally this should be at two heights: between 950mm and 1100mm to accommodate people standing and at 760mm for wheelchair users and be clear of furniture below.

6.3	Main Reception - The desk is at approx 1100mm high, this should have a lower section plus sufficient knee space both sides for people sitting or wheelchair users. Ideally this should be at two heights: between 950mm and 1100mm to accommodate people standing and at 760mm for wheelchair users and be clear of furniture below.	Replace the reception desk at the next refurbishment. BS8300 criteria will be satisfied if at least one section of the counter is at least 1500mm wide, with its surface no higher than 760mm.	<b>OG</b>

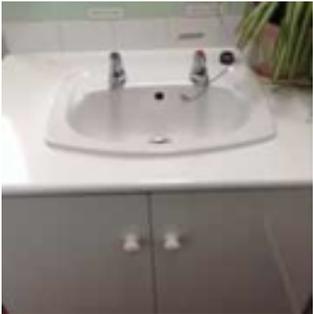
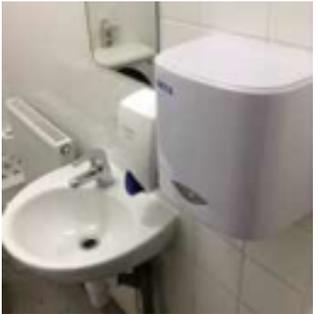
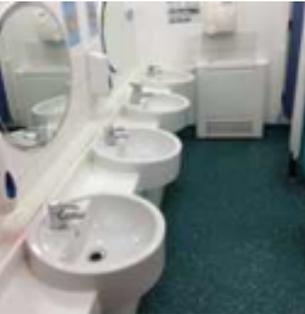
Appendix 37	Appendix 38	Appendix 39

Question	Response	Details
<b>Checklist 12 - WC Provision &amp; Changing Areas</b>		
12.1 - Lobby door light enough to open easily? Lobby of sufficient size for easy access?	Yes	
12.2 - Slip-resistant floors throughout?	Yes	Slip resistant flooring is provided throughout the toilets.
12.3 - Fittings all easily distinguishable from background? Are hand dryers and sanitary ware easily seen against their surroundings?	No	Throughout WCs numerous sanitary ware was not sufficiently colour contrasted against the surroundings to aid people with impaired vision.

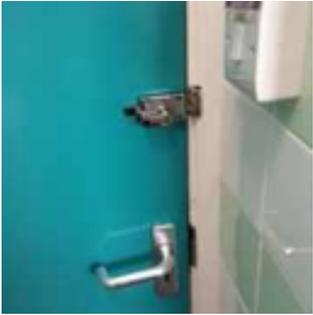
<p data-bbox="248 675 367 699">Appendix 40</p>

Question	Response	Details
12.4 - Compartment door controls all easily gripped and operated? Are cubicle doors suitably colour contrasted against the panels?	No	One of the WCs - The door control is not easy to use for those with dexterity impairments.

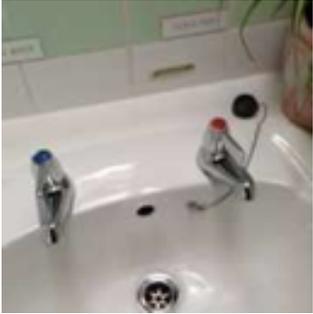
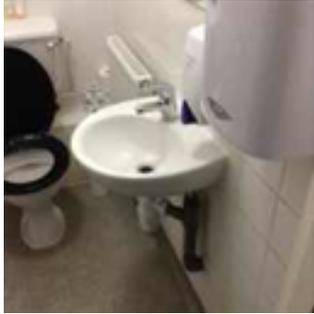
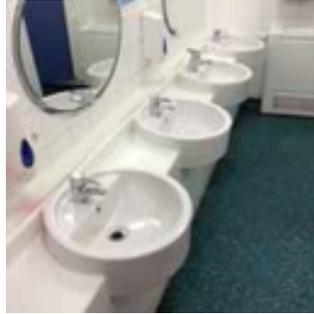
<p data-bbox="248 1265 367 1289">Appendix 41</p> <p data-bbox="568 1265 687 1289">Appendix 42</p> <p data-bbox="889 1265 1008 1289">Appendix 43</p>

12.5 - Are urinals well contrasted and do they have grab rails to assist people with ambulant disabilities?	N/A	
12.6 - Are lever style taps provided within the WCs to aid people with dexterity impairments?	Yes	Throughout the WCs, lever taps are provided which are easy to use for people with dexterity impairments.

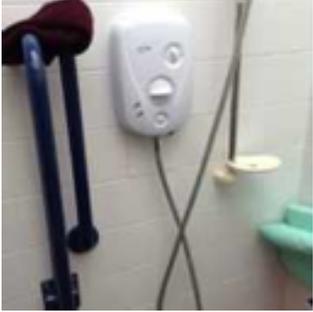
<p data-bbox="248 639 367 663">Appendix 44</p>

Question	Response	Details
12.8 - Where there are shower facilities, is a grab rail provided? Is there a level access shower for disabled people?	No	There is a grab rail provided for the shower. The shower controls are not easy to use for people with dexterity impairments.

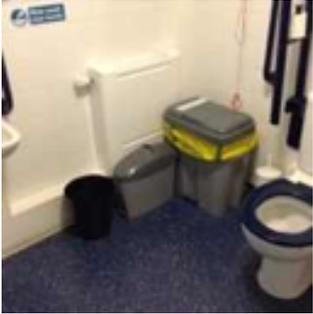
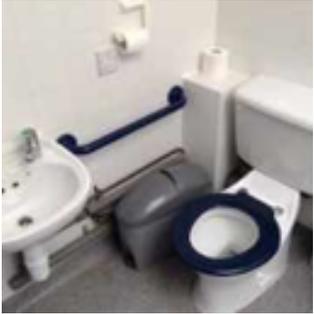
Question	Response	Details
<p>13.4 - Hand washing and dry facilities within easy reach of someone seated on WC? Is the hand basin suitably positioned in accordance to BS8300?</p>	<p>No</p>	<p>Near Reception accessible WC - The hand wash basin is not within easy reach whilst seated on the toilet pan. There is a hand dryer provided to aid people who may struggle to use hand towels however this is not colour contrasted against the background to aid people with impaired vision.</p> <p>Nursery School accessible WC - The hand wash basin is within easy reach whilst seated on the toilet pan. There is a hand dryer provided to aid people who may struggle to use hand towels however this is not colour contrasted against the background to aid people with impaired vision.</p>
<div style="display: flex; justify-content: space-around;"> <div style="text-align: center;">

13.4A	Near Reception accessible WC - The hand wash basin is not within easy reach whilst seated on the toilet pan.	It is strongly recommended that the hand wash basin be repositioned. Refer to BS8300 for guidance.	<b>M</b>

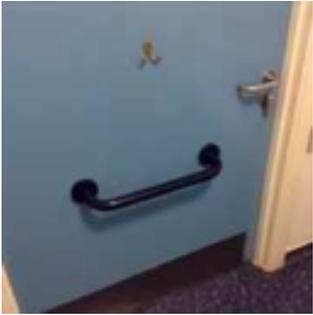
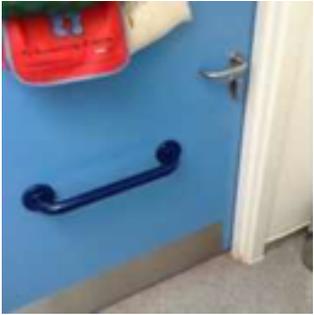
Question	Response	Details
13.5 - Door controls, lock and light switch easily reached and operated? Is there a grab rail to the inner face of the entrance?	Yes	Both accessible WCs - Grab rail on the door is provided. There is a lever lock that is easy to use for those with dexterity impairments. Sensor lighting is provided.

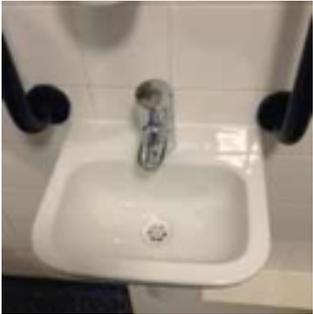
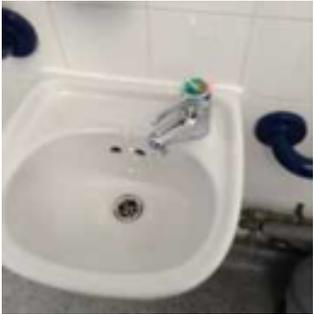
<p>Appendix 48</p>		
13.6 - Tap appropriate for use by a person with limited dexterity, grip or strength?	Yes	Both accessible WCs have lever taps to aid people with dexterity impairments.

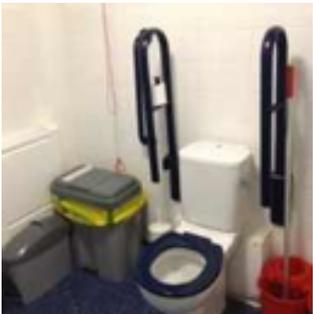
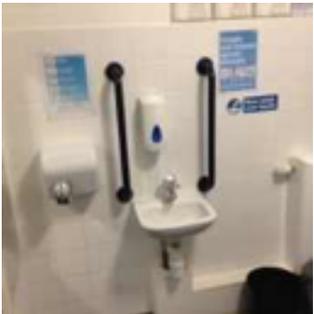
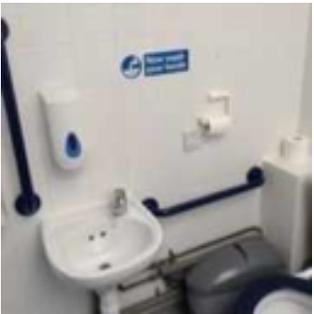
Question	Response	Details
<p>13.7 - Suitably designed grab rails fitted in all positions necessary to assist manoeuvring? Are grab rails suitably colour contrasted to aid people with impaired vision?</p>	<p>No</p>	<p>Near Reception accessible WC - The blue grab rails against the white background are suitably colour contrasted.</p> <p>Nursery School - The blue grab rails against the white background are suitable colour contrasted however there is only one vertical grab rail to one side of the basin.</p>
<div style="display: flex; justify-content: space-around; align-items: flex-end;"> <div style="text-align: center;">

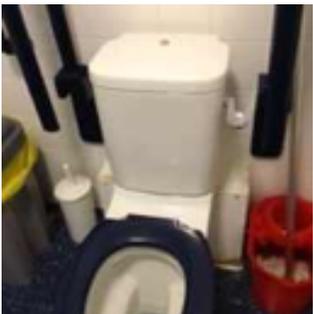
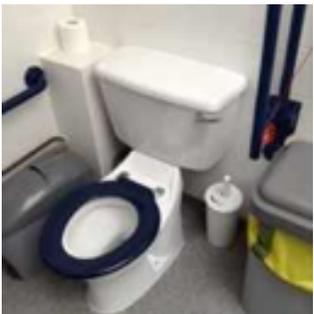
<p>Appendix 53</p> </div> </div>		
<p>13.8 - Is there a back rest provided to the toilet pan?</p>	<p>No</p>	<p>Neither of the accessible WCs has a back support.</p>

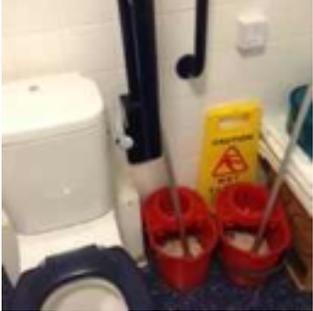
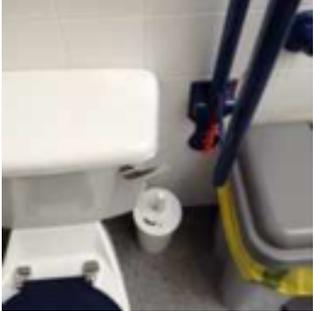
Question	Response	Details
<p>13.9 - Is the flush of a suitable spatula type and is it appropriately located on the transfer side of the toilet pan?</p>	<p>No</p>	<p>Near Reception - This accessible WC does have a suitable spatula type flush handle and it is positioned on the correct side of the cistern.</p> <p>Nursery School - This accessible WC does not have a suitable spatula type flush. It is positioned on the correct side of the cistern.</p>
<div style="display: flex; justify-content: space-around;"> <div data-bbox="152 496 465 807">

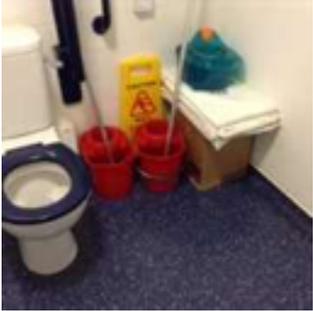
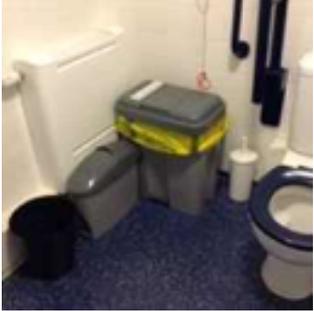
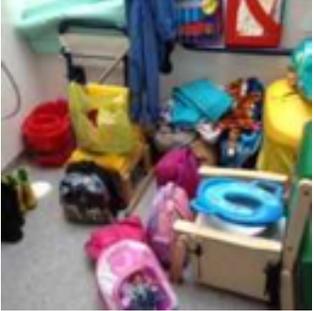
<p data-bbox="571 815 689 839">Appendix 57</p> </div> </div>		
<p>13.10 - Is the transfer side of the toilet pan kept clear of any obstacles that may deny wheelchair users all of the transferring techniques in which an accessible WC is designed to provide?</p>	<p>No</p>	<p>Both accessible WCs - On the day of the survey, bins and many items were positioned within the transfer area.</p>

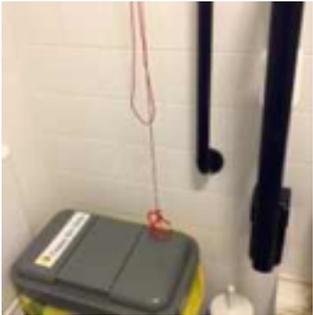
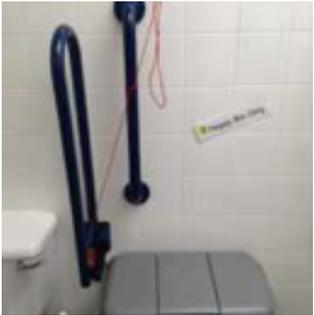
Question	Response	Details
13.11 - Is there a cord alarm? Is this coloured red with two triangular bangles and easy to reach from floor level?	No	Near Reception accessible WC - There is a pull cord alarm however the bangles were tied up.  Nursery School accessible WC - There is a pull cord alarm however the bangles were tied to the grab rail.
<div style="display: flex; justify-content: space-around;"> <div data-bbox="152 422 465 737">

13.11	Near Reception accessible WC - There is a pull cord alarm however the bangles were tied up.  Nursery School accessible WC - There is a pull cord alarm however the bangles were tied to the grab rail.	Implement management procedure to ensure that the alarm cord is never tied up and always hanging loose.  According to BS8300 - An emergency assistance pull cord should be sited so that it can be operated from the WC and from an adjacent floor area. The emergency assistance pull cord, coloured red, should be provided with two red bangles of 50 mm diameter, one set at a height between 800 mm and 1000 mm and the other set at 100 mm above floor level.	<b>M</b>

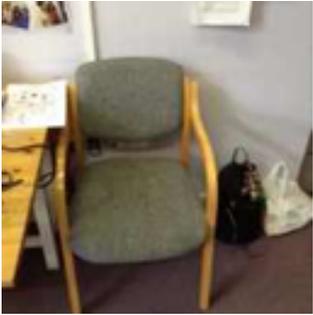
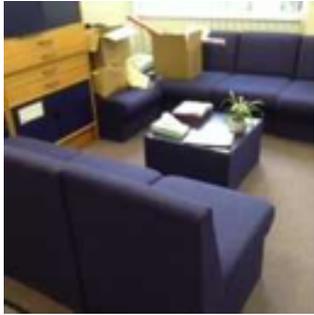
Question	Response	Details
14.2 - Seats stable, with armrests and provided in a range of heights? Space for wheelchair user to pull up alongside a seated companion?	Yes	There are seats with armrests provided within the Staff Rest Room to aid people with ambulant disabilities.

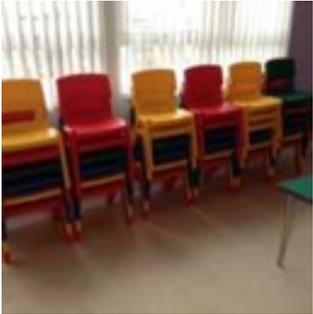
<p>Appendix 65</p>		
14.4 - Do dining room counters have provision on both sides for wheelchair users? Do these counters have an induction loop to accommodate hearing aid users?	N/A

<p>Appendix 64</p>		
14.3 - Are a number of chairs with armrests available within each classroom?	No	There are no chairs with armrests in any classrooms.

14.3	There are no chairs with armrests in any classrooms.	Ensure that there is a chair with armrests available within each of the classrooms. This is a recommendation that may need to be phased.	<b>M</b>

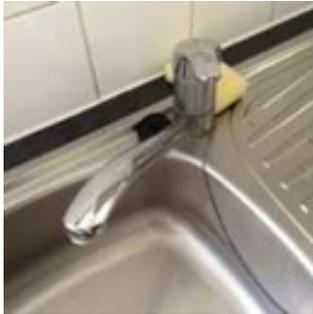
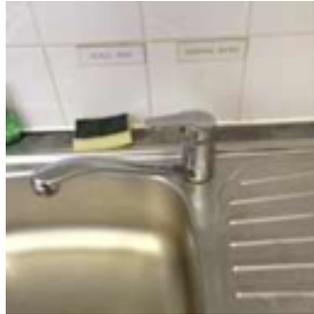
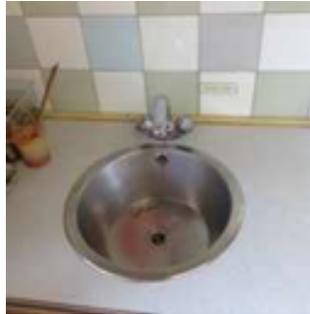
Question	Response	Details
14.10 - Does the kitchen sink within the Staff Room have a lever tap to accommodate people with dexterity impairments?	No	<p>Nursery School - There is no lever tap provided that is easy to use for people with dexterity impairments.</p> <p>Staff Rest Room and Kitchen - There are lever taps provided that are easy to use for people with dexterity impairments.</p> <p>No accessible tables were identified within the employee working areas.</p>
