Accessibility Audit

Low Hall Nursery School

Low Hall Lane

Date 07/03/2017

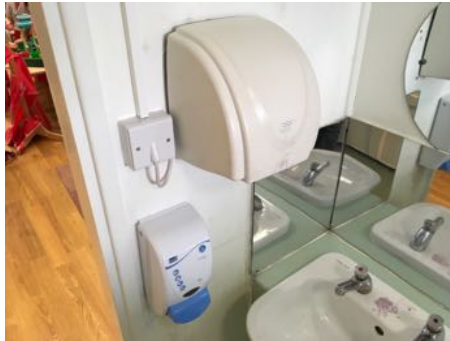
Photo 33

Question	Response	Details
12.3 - Fittings all easily distinguishable from background? Are hand dryers and sanitary ware easily seen against their surroundings?	B	Throughout the WCs the colour contrast is poor. The fittings and fixtures are not easily seen against their backgrounds.
<div data-bbox="118 360 441 606" data-label="Image"> </div> <div data-bbox="230 651 324 675" data-label="Caption">Photo 31</div> <div data-bbox="452 360 775 606" data-label="Image"> </div> <div data-bbox="564 651 658 675" data-label="Caption">Photo 32</div> <div data-bbox="786 360 1108 606" data-label="Image"> </div> <div data-bbox="898 651 992 675" data-label="Caption">Photo 33</div>

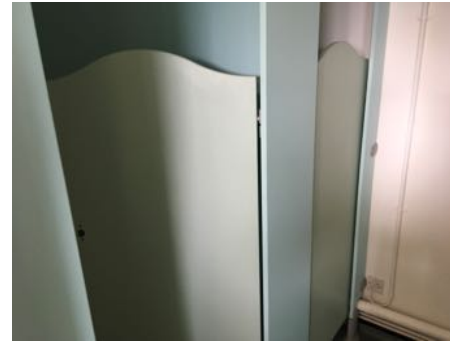
Photo 35

12.4 - Compartment door controls all easily gripped and operated? Are cubicle doors suitably colour contrasted against the panels?	D	Cubicle doors are not appropriately colour contrasted to aid people with impaired vision.
<div data-bbox="118 887 441 1133" data-label="Image"> </div> <div data-bbox="230 1177 324 1201" data-label="Caption">Photo 34</div> <div data-bbox="452 887 775 1133" data-label="Image"> </div> <div data-bbox="564 1177 658 1201" data-label="Caption">Photo 35</div>

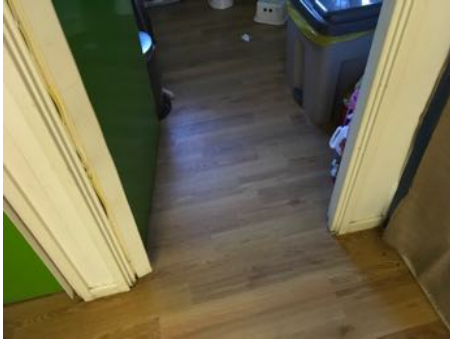
Photo 41

</div> <p data-bbox="237 687 322 708">Photo 41</p>		
<p>13.4 - Hand washing and dry facilities within easy reach of someone seated on WC? Is the hand basin suitably positioned in accordance to BS8300?</p>	<p>B</p>	<p>The fittings within the accessible WC are not colour contrasted against their surround to aid people with impaired vision.</p> <p>There is no hand drier facility to aid those who find it difficult to use paper towels.</p>

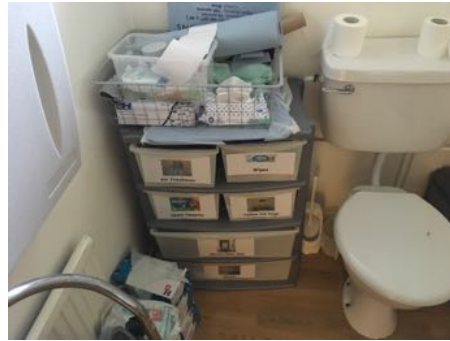
Photo 47

<p>Photo 47</p>		
13.11 - Is there a cord alarm? Is this coloured red with two triangular bangles and easy to reach from floor level?	A	The accessible WC does not feature a cord alarm, should someone require assistance they would not be able to make a distress call.

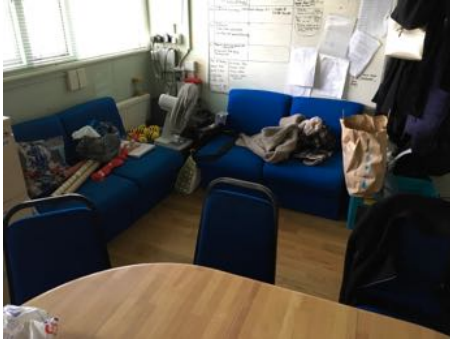
Photo 49

Question	Response	Details
14.1 - Are seats provided at intervals along long internal routes or where waiting likely?	D	There are no chairs with armrests provided within the staff room to aid ambulant disabled persons.
<div data-bbox="120 327 441 571" data-label="Image"> </div> <div data-bbox="230 617 327 641" data-label="Caption"> <p>Photo 49</p> </div>
